# DAM SAFETY INSPECTION REPORT

## SWIFT RUN LAKE DAM

FILE NUMBER: 0142-001

INSPECTED: NOVEMBER 26, 2024

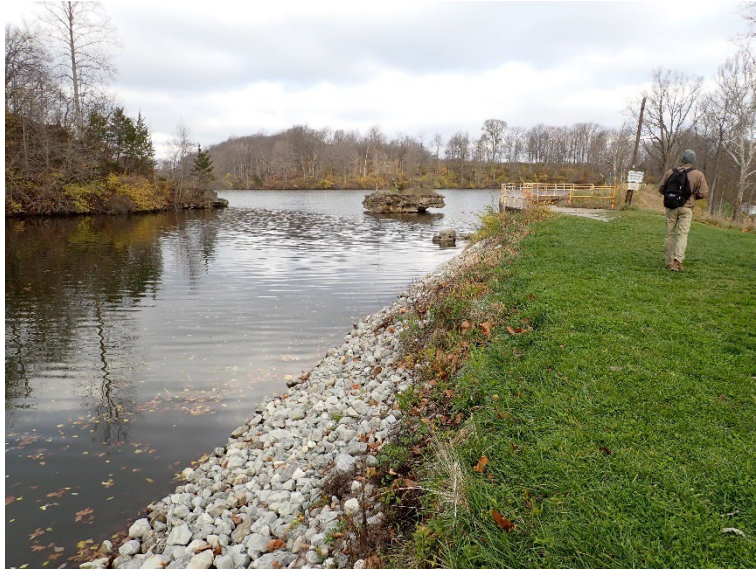
1. Upstream slope and crest at the far-right end of the dam.

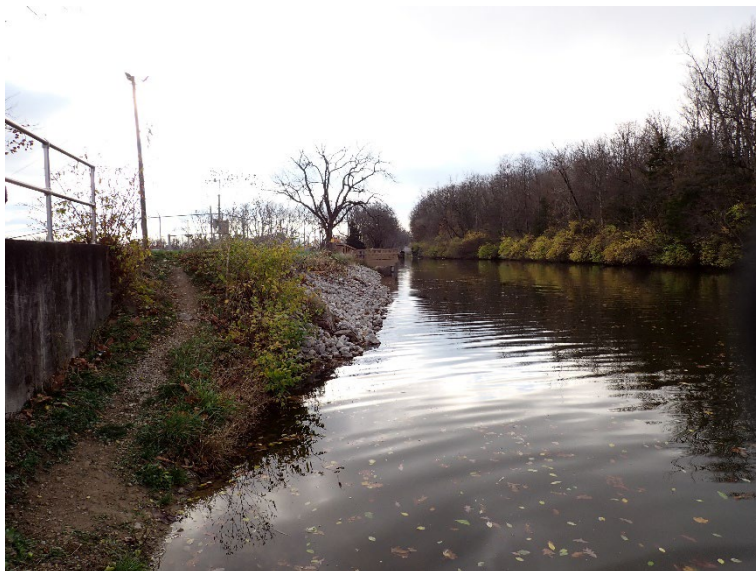
2. Upstream slope adjacent to the right sidewall of spillway #2. Note the erosion and lack of vegetal cover.

3. The erosion on the upstream slope of the embankment must be repaired and the upstream slope must be protected from erosion. Prepare plans and specifications for repairing the erosion and installing erosion protection. The erosion must be monitored quarterly until repairs can be made. See the "Upstream Slope Protection" fact sheet for additional information.

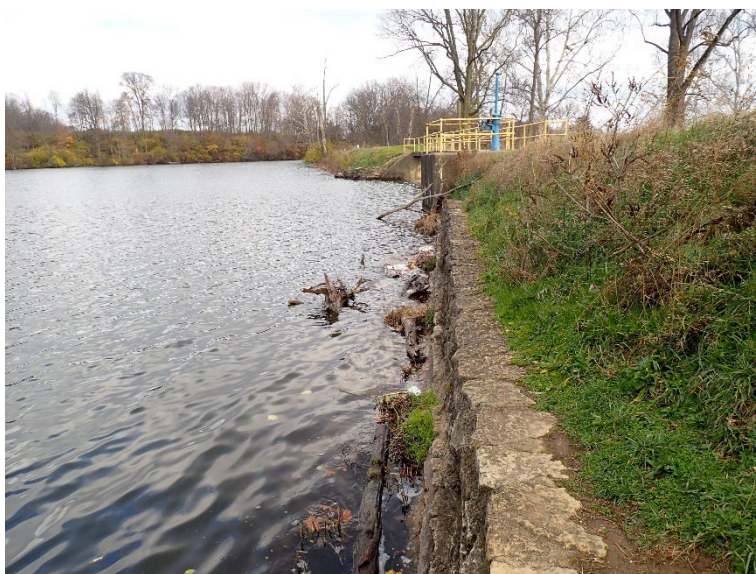
3. Retaining wall and upstream slope between spillway #2 and #3. The vegetation on the slope is too tall.

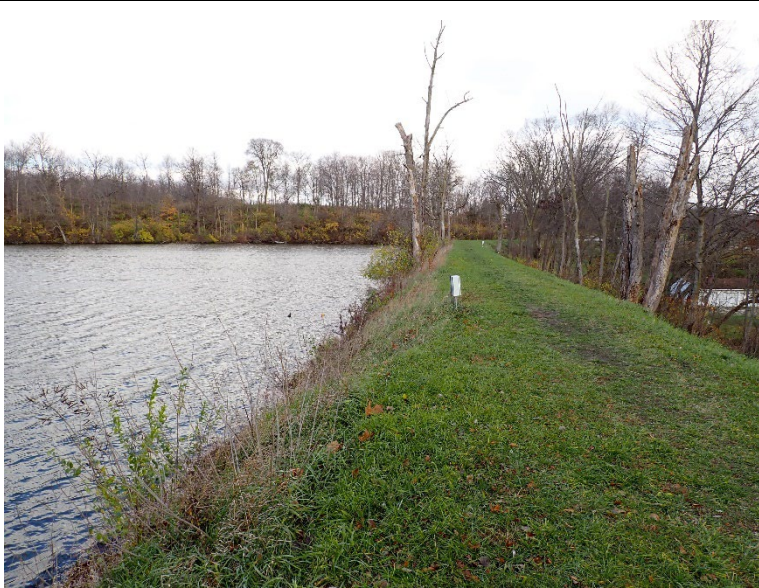
4. Upstream slope and crest to the left of spillway #3.

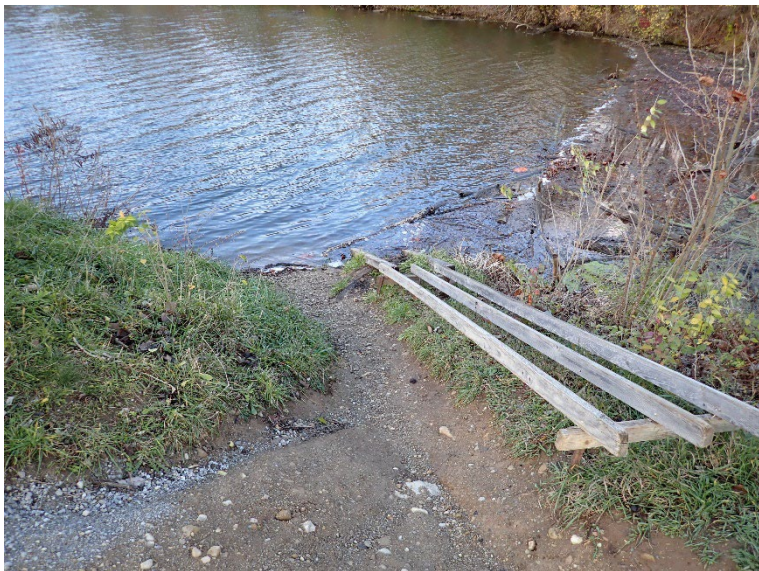
5. Erosion of the upstream slope near the left end of the dam.

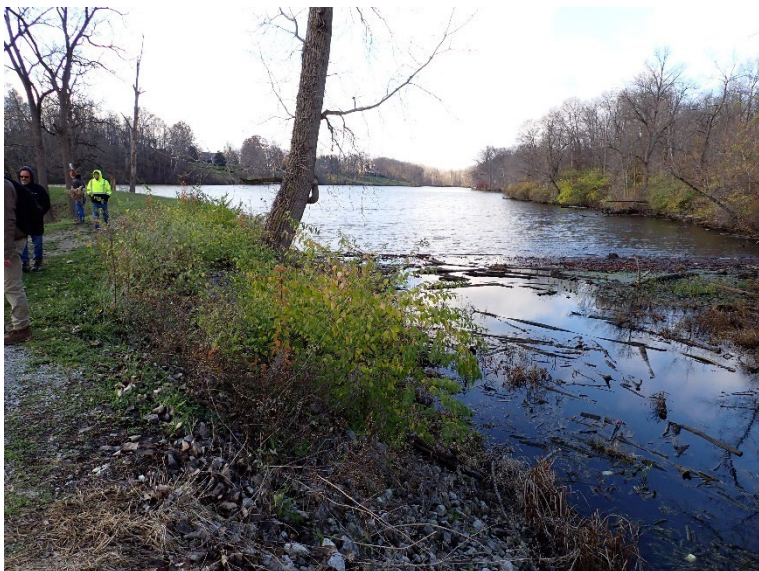
6. Upstream slope at the far-left end of the dam. Again, note the tree and the too tall vegetation.

1. Remove the trees and brush from the upstream slope, downstream slope, and the canal embankments. After the slopes are cleared, inspect for cracks, rodents, erosion, and slides. Seed all disturbed areas to establish a proper grass cover. See the "Trees and Brush" fact sheet for additional information.

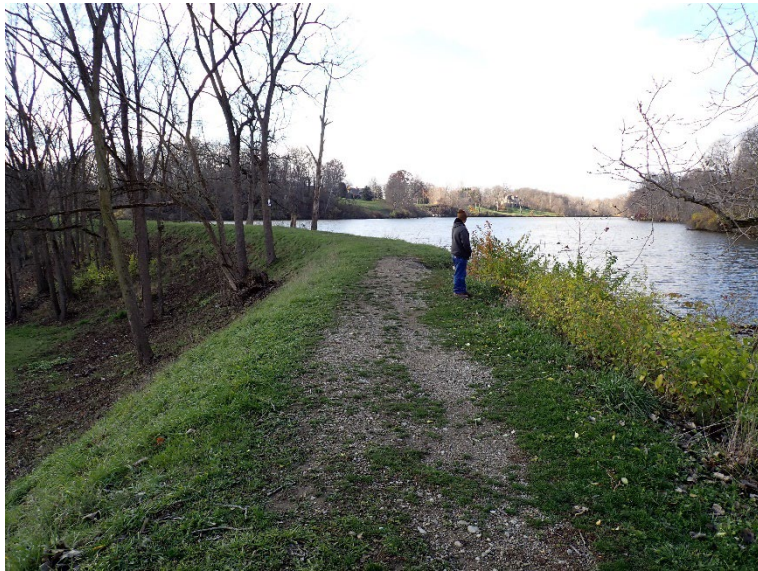
7. Crest at the left end of dam. Note the large bare area.

2. Seed all bare areas on the dam crest and downstream slope to establish a proper grass cover. See the "Ground Cover" fact sheet for additional information.

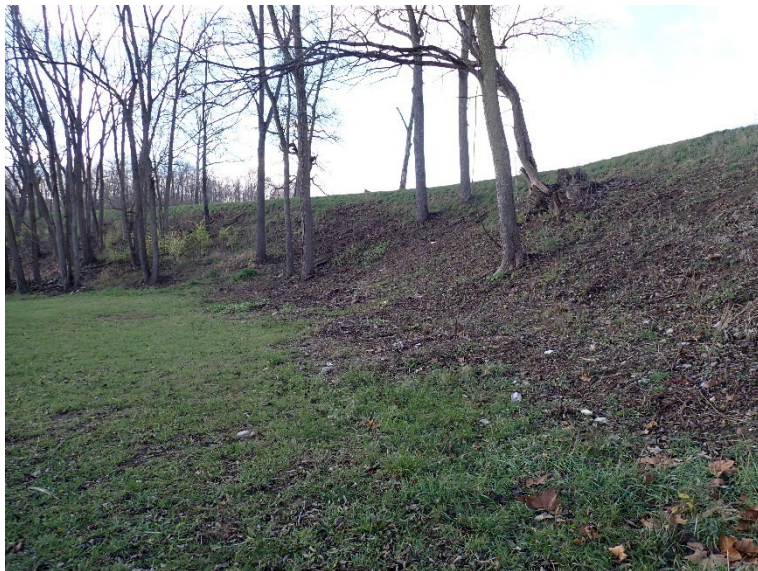
8. Large bare areas on the downstream slope near the left end of the dam. Also note the trees.

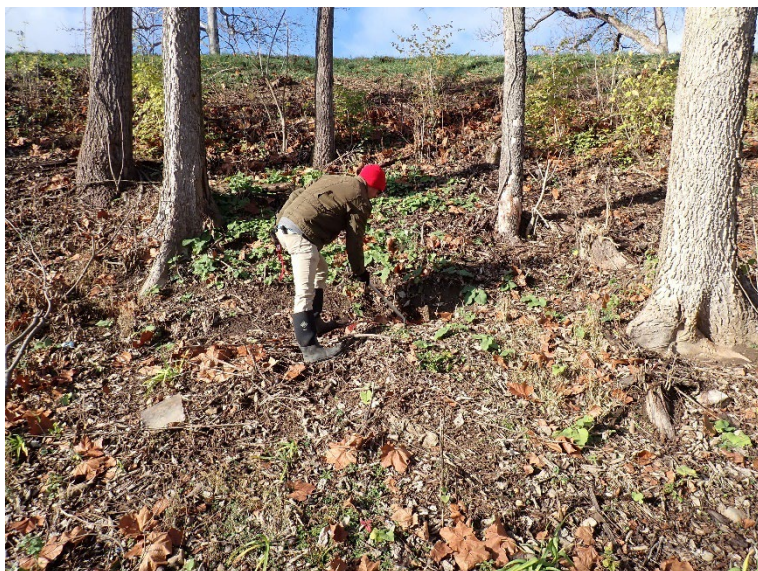
9. A view of a rodent burrow identified on the downstream slope.

3. Repair the rodent burrows on both the dam and canal embankments. See the "Rodent Control" fact sheet for additional information.
4. Continue to perform routine maintenance of the lake drains. The maintenance should be performed annually and should include operation and lubrication of the valves and sluice gate in accordance with the manufacturer's specifications. Use caution if the operability of the lake drain valve is unknown. See the "Lake Drains" fact sheet for additional information.

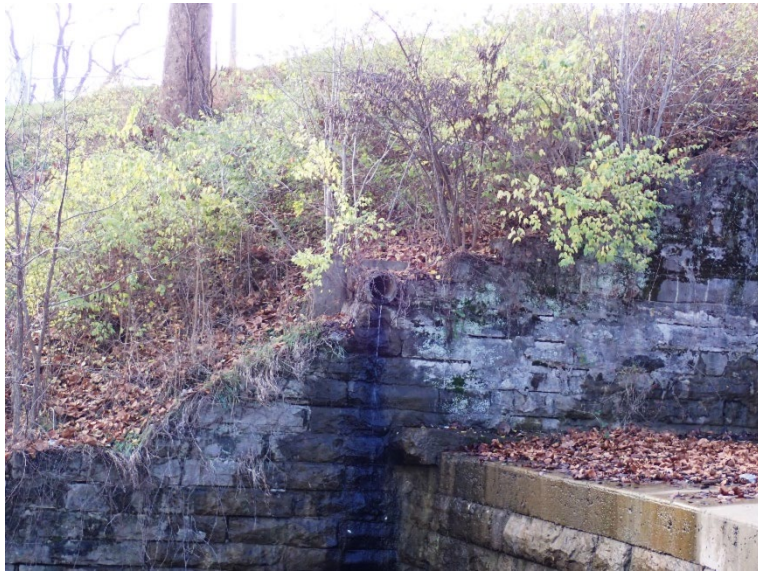
10. Downstream slope to the right of spillway #2. Note trees and dense overgrowth of brush.

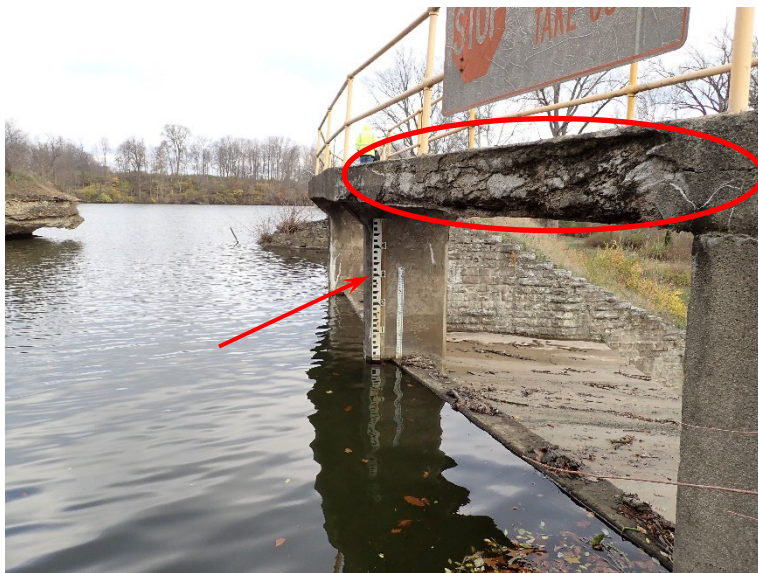
11. Inlet to spillway #2. Note the severe deterioration of the concrete (circled) and the location of the staff gauge (arrow).

2. Every dam shall have a spillway system which will safely operate during the design flood without endangering the safety of the dam in accordance with OAC Rule 1501:21-13-03. Review of the structural investigation performed by Stantec in 2023 indicates the need for both concrete spillways to be fully replaced. Prepare plans and specifications for the construction of a new spillway. The condition of the two spillways must be monitored quarterly until repairs can be made. See the "Open Channel Spillways (Concrete chutes and Weirs)" fact sheet for additional information. This item should be completed in coordination with Item 1 above.

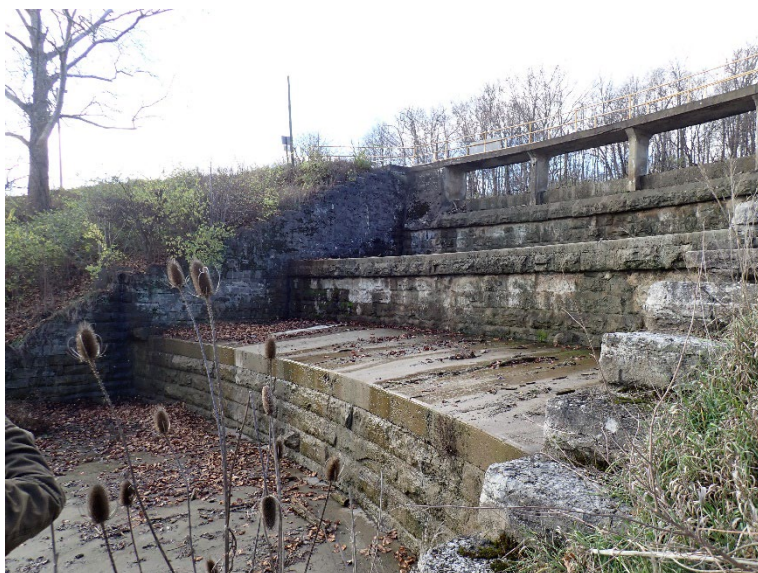
12. Spillway #2 outlet. Note the seepage through the joints.

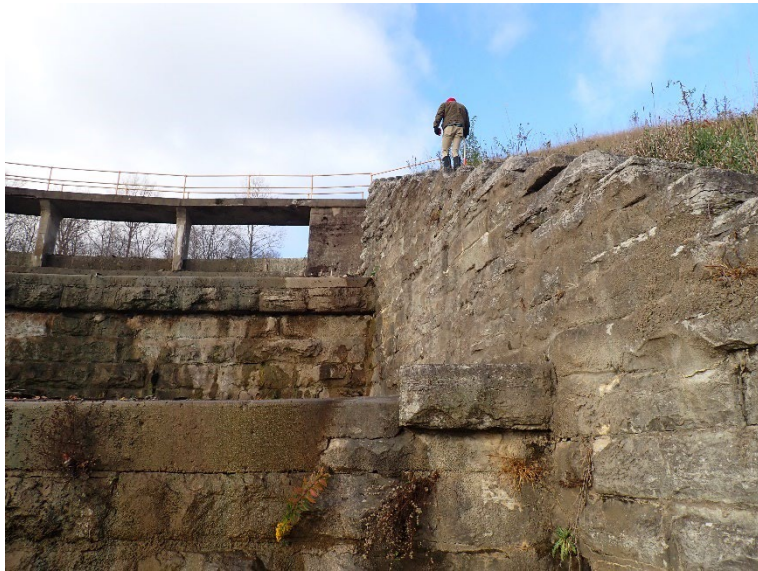
13. Left sidewall of spillway #2. Note the stone is deteriorating and vegetation growing between the joints.

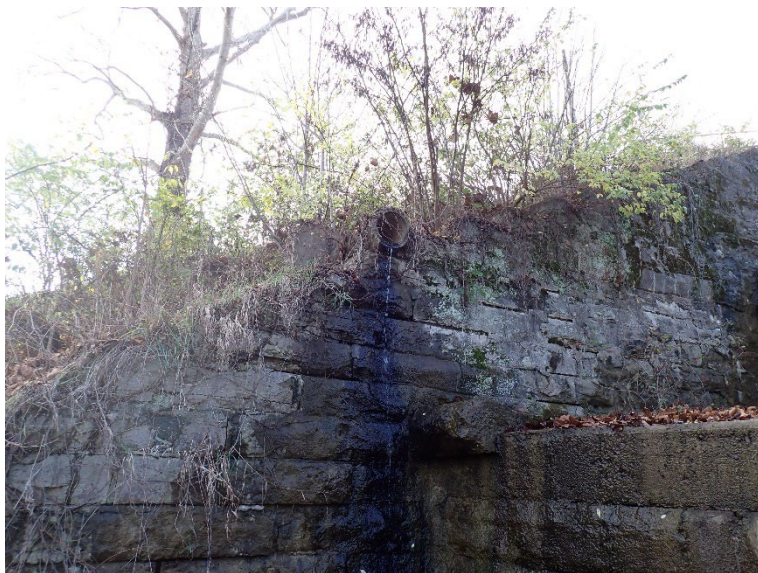
14. A surface drain discharging over the right sidewall of spillway #2.

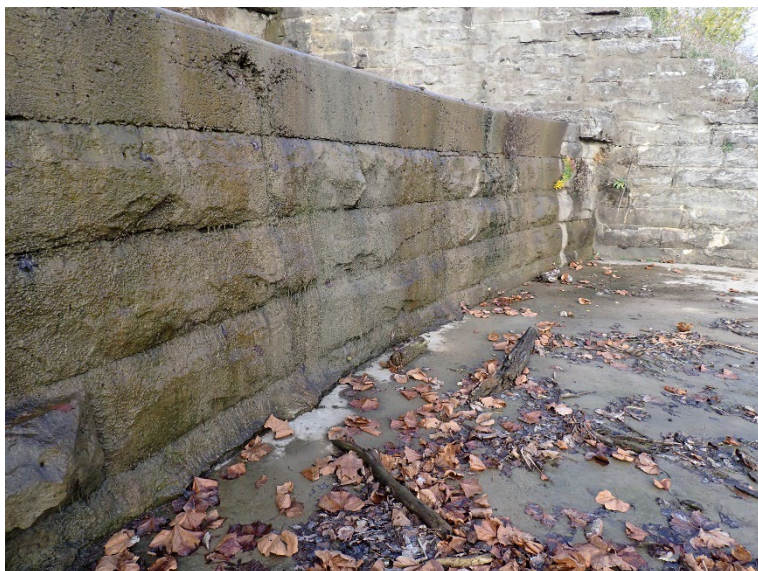
15. Although Spillway #2 was not flowing, the stepped faces of the outlet were wet.

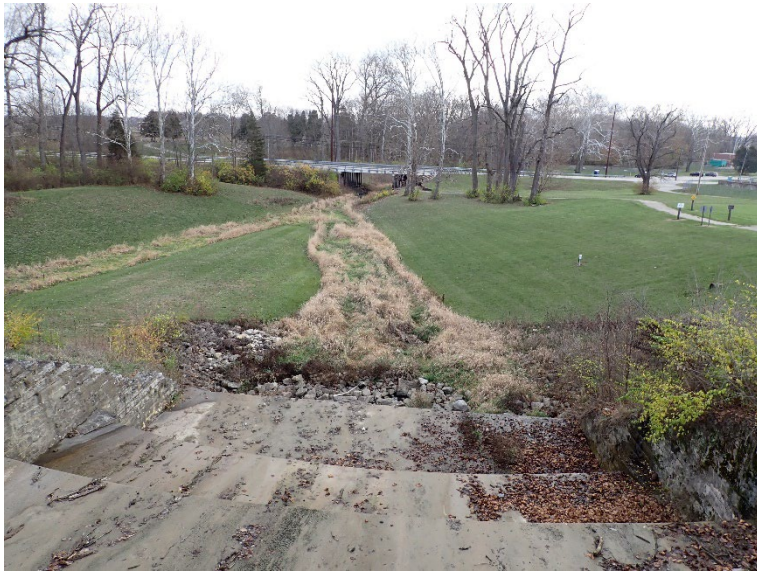
16. Outlet channel downstream of spillway #2 (center). The channel on left side of this photo is the outlet channel for spillway #3.

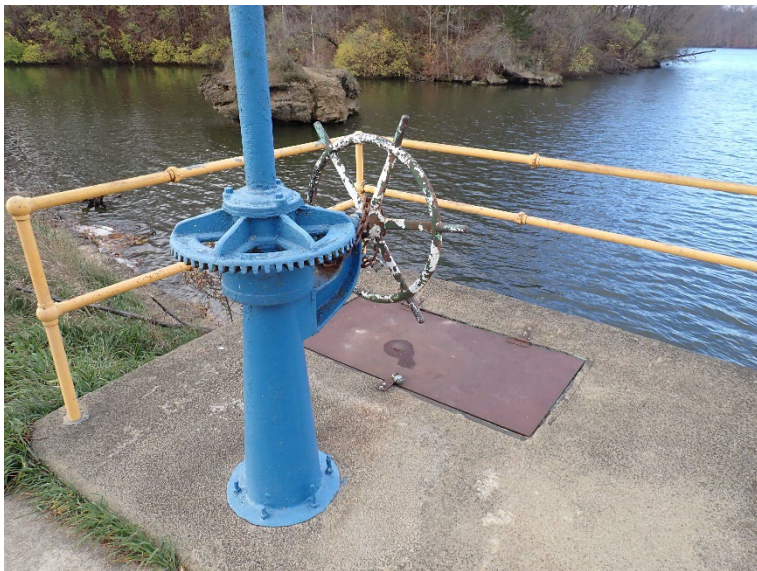
17. Lake drain control at the right side of spillway #3.

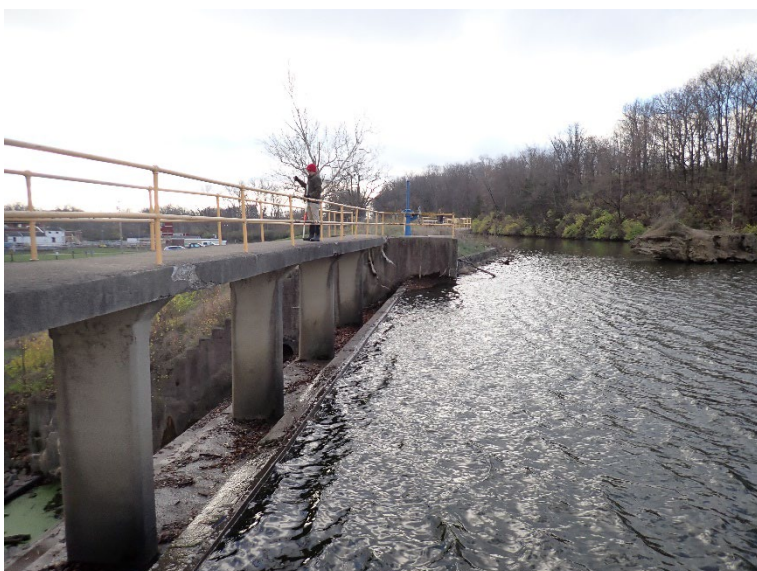
18. Spillway #3 inlet.

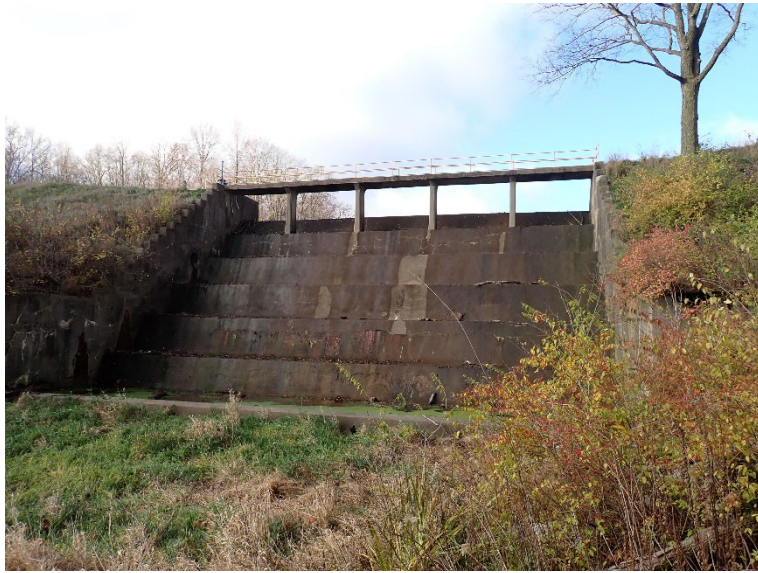
19. Spillway #3 outlet.

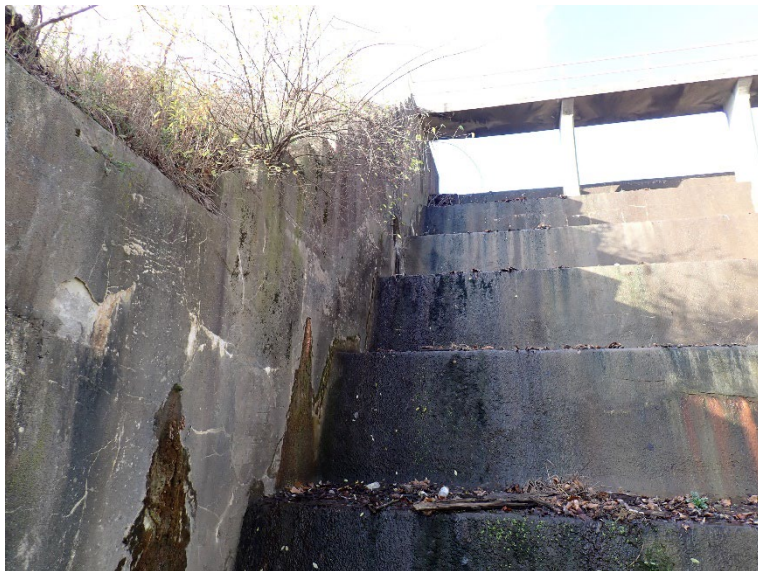
20. Right sidewall of spillway #3. Note the deterioration, efflorescence, and seepage.

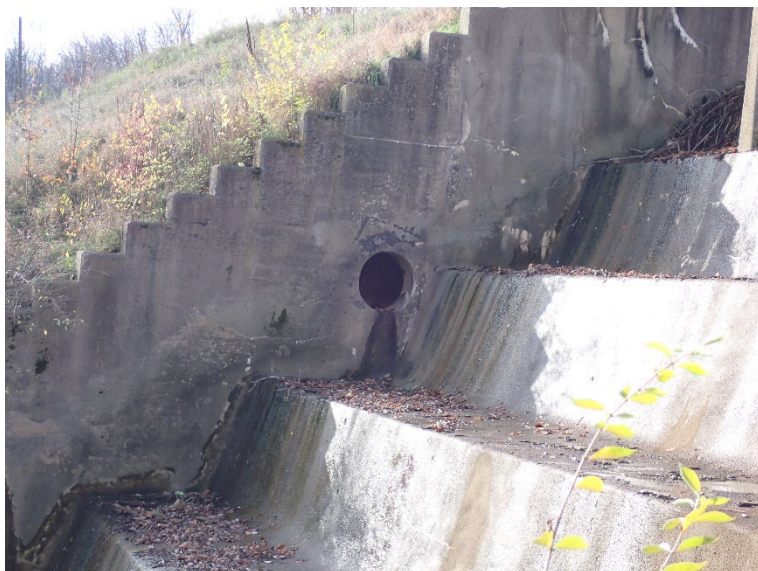
21. The lake drain discharges through the right sidewall of spillway #3.

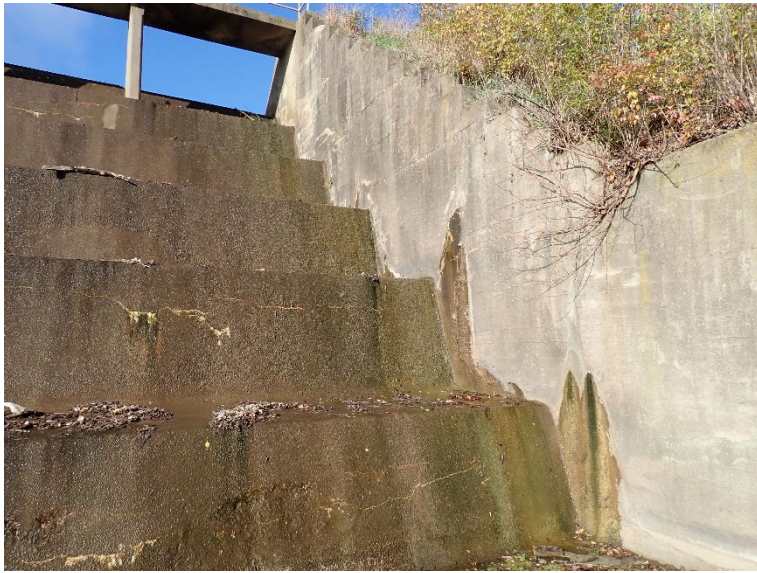
22. Cracking and seepage through the left sidewall of spillway #3.

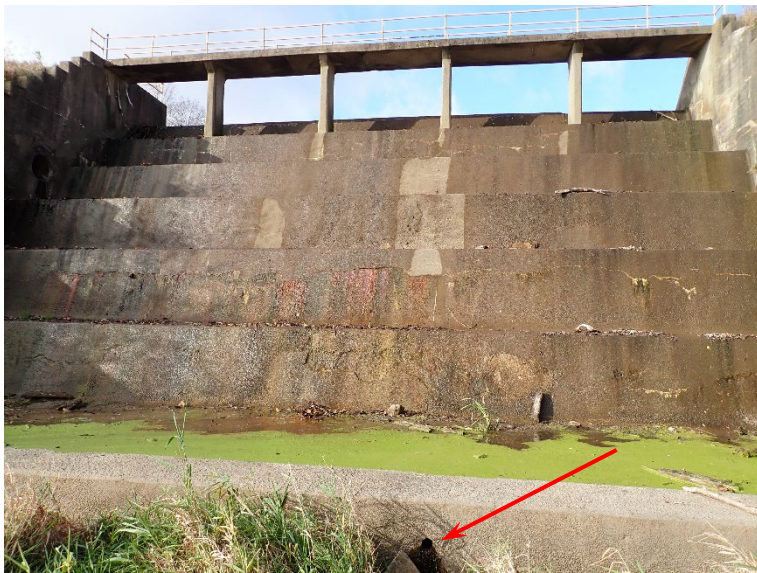
23. View of spillway #3 outlet steps and stilling basin. Note the delamination of the concrete on the steps. Arrow points to a drain for the stilling basin.

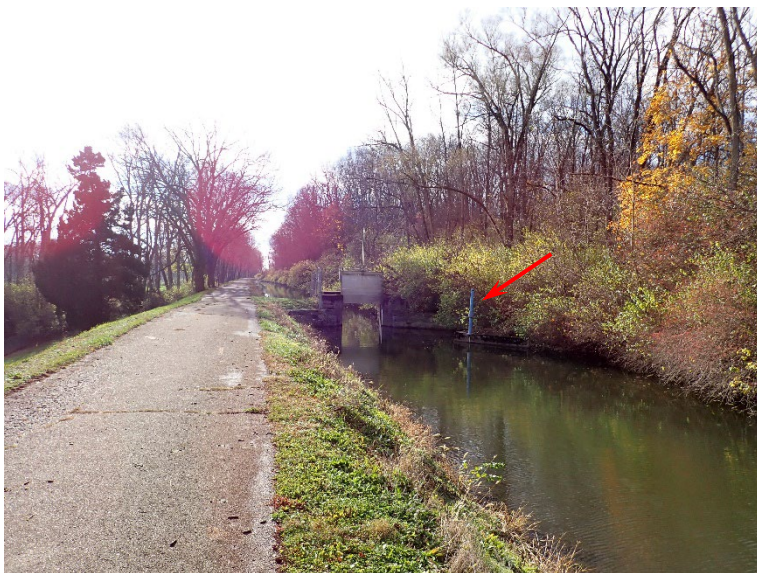
24. Gate to separate the canal from Swift Run Reservoir. Arrow points to a valve control to allow water to bypass gate.
